# CABOOLTURE AERO CLUB

## SAFETY NOTICE TO MEMBERS

3/25

DAMAGE TO TAXIWAY SURFACE

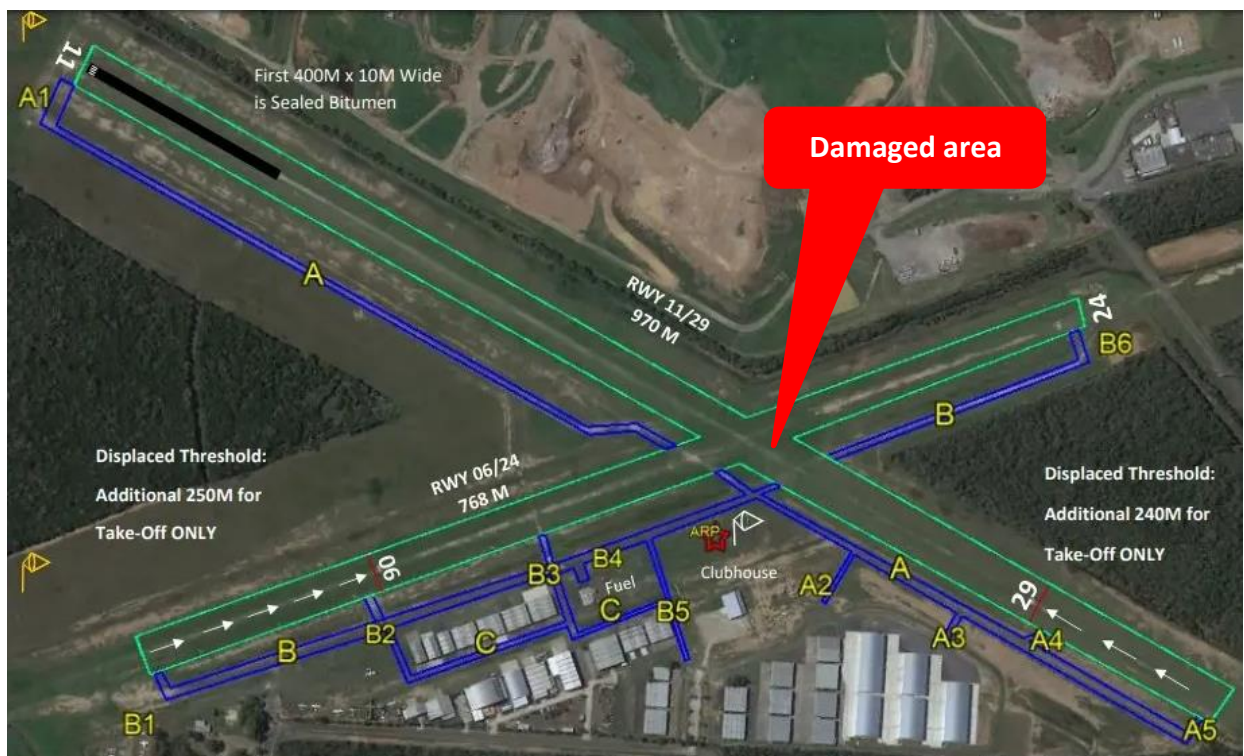
Aging infrastructure and recent rains have created a hole in the taxiway surface on the East side of the Runway 11/29 Holding point near the main windsock. This area is marked by a RED/WHITE Marker Cone.

- Potential damage to aircraft
- Further damage to taxiway surface

This notice is intended to advise pilots that this hazard exists.

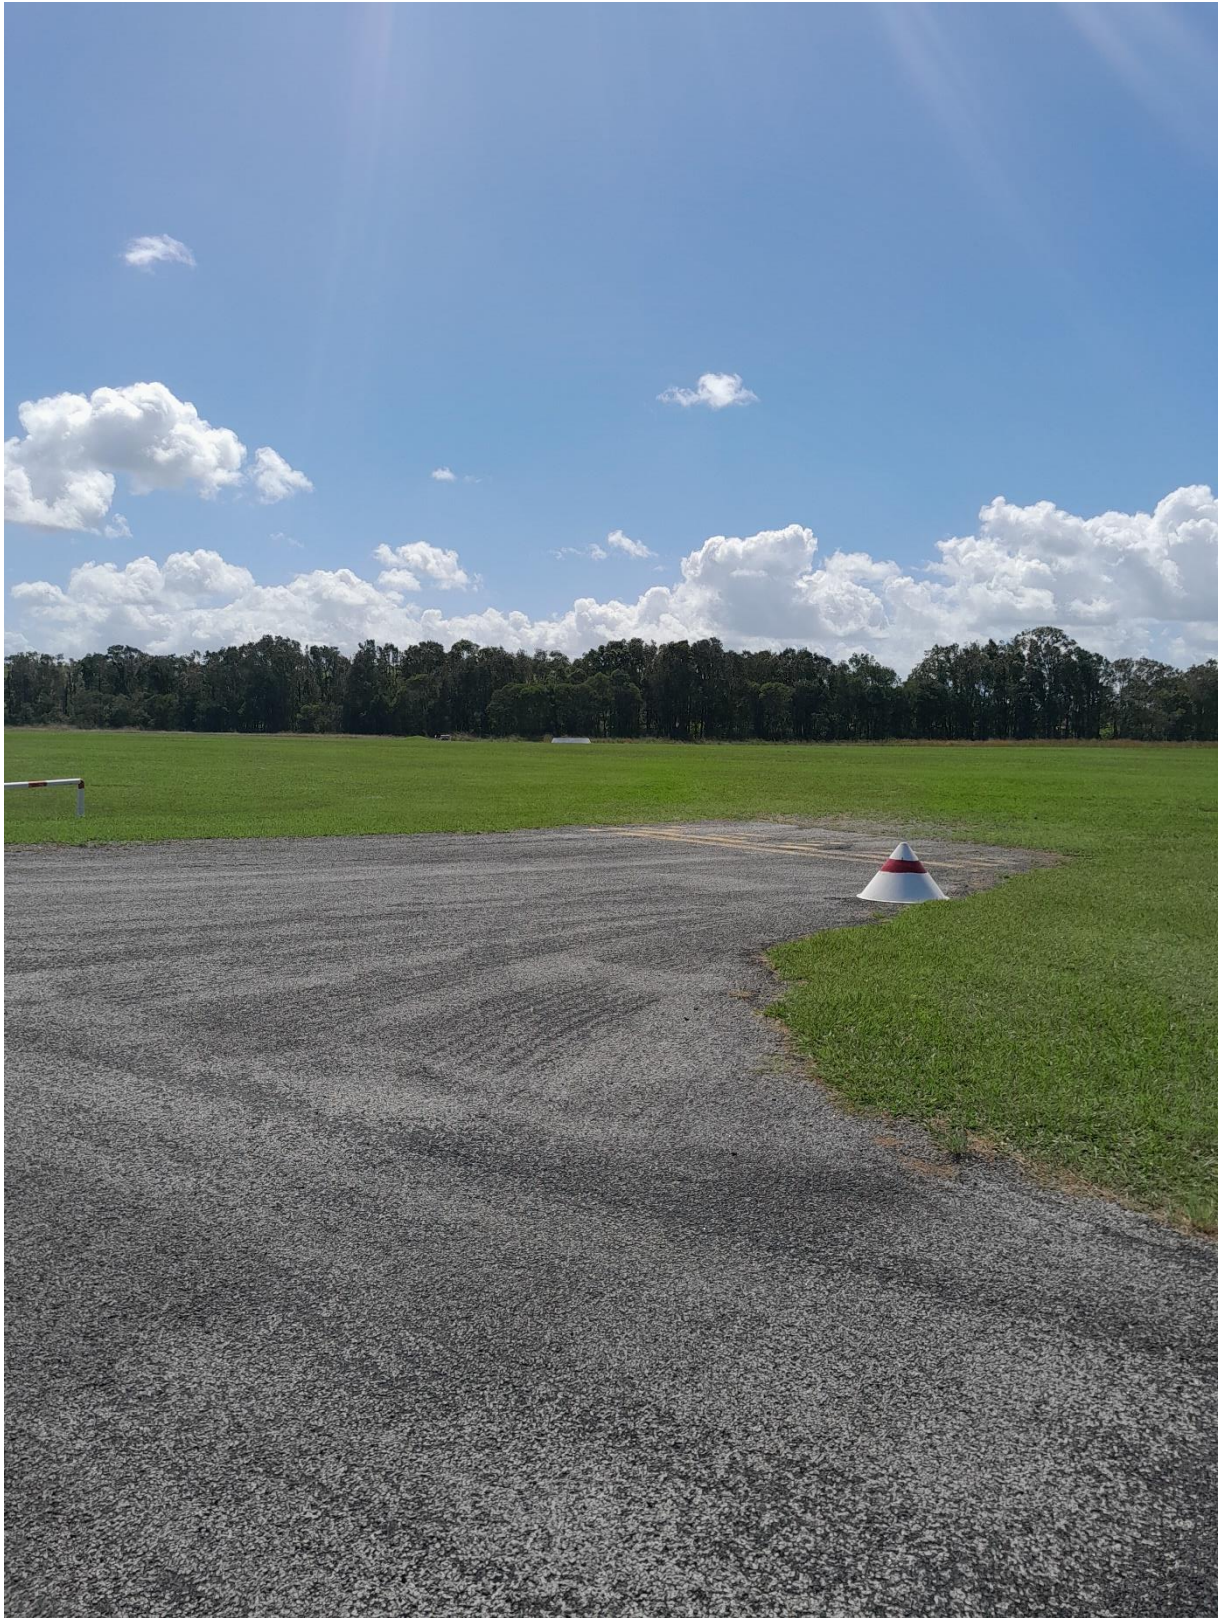
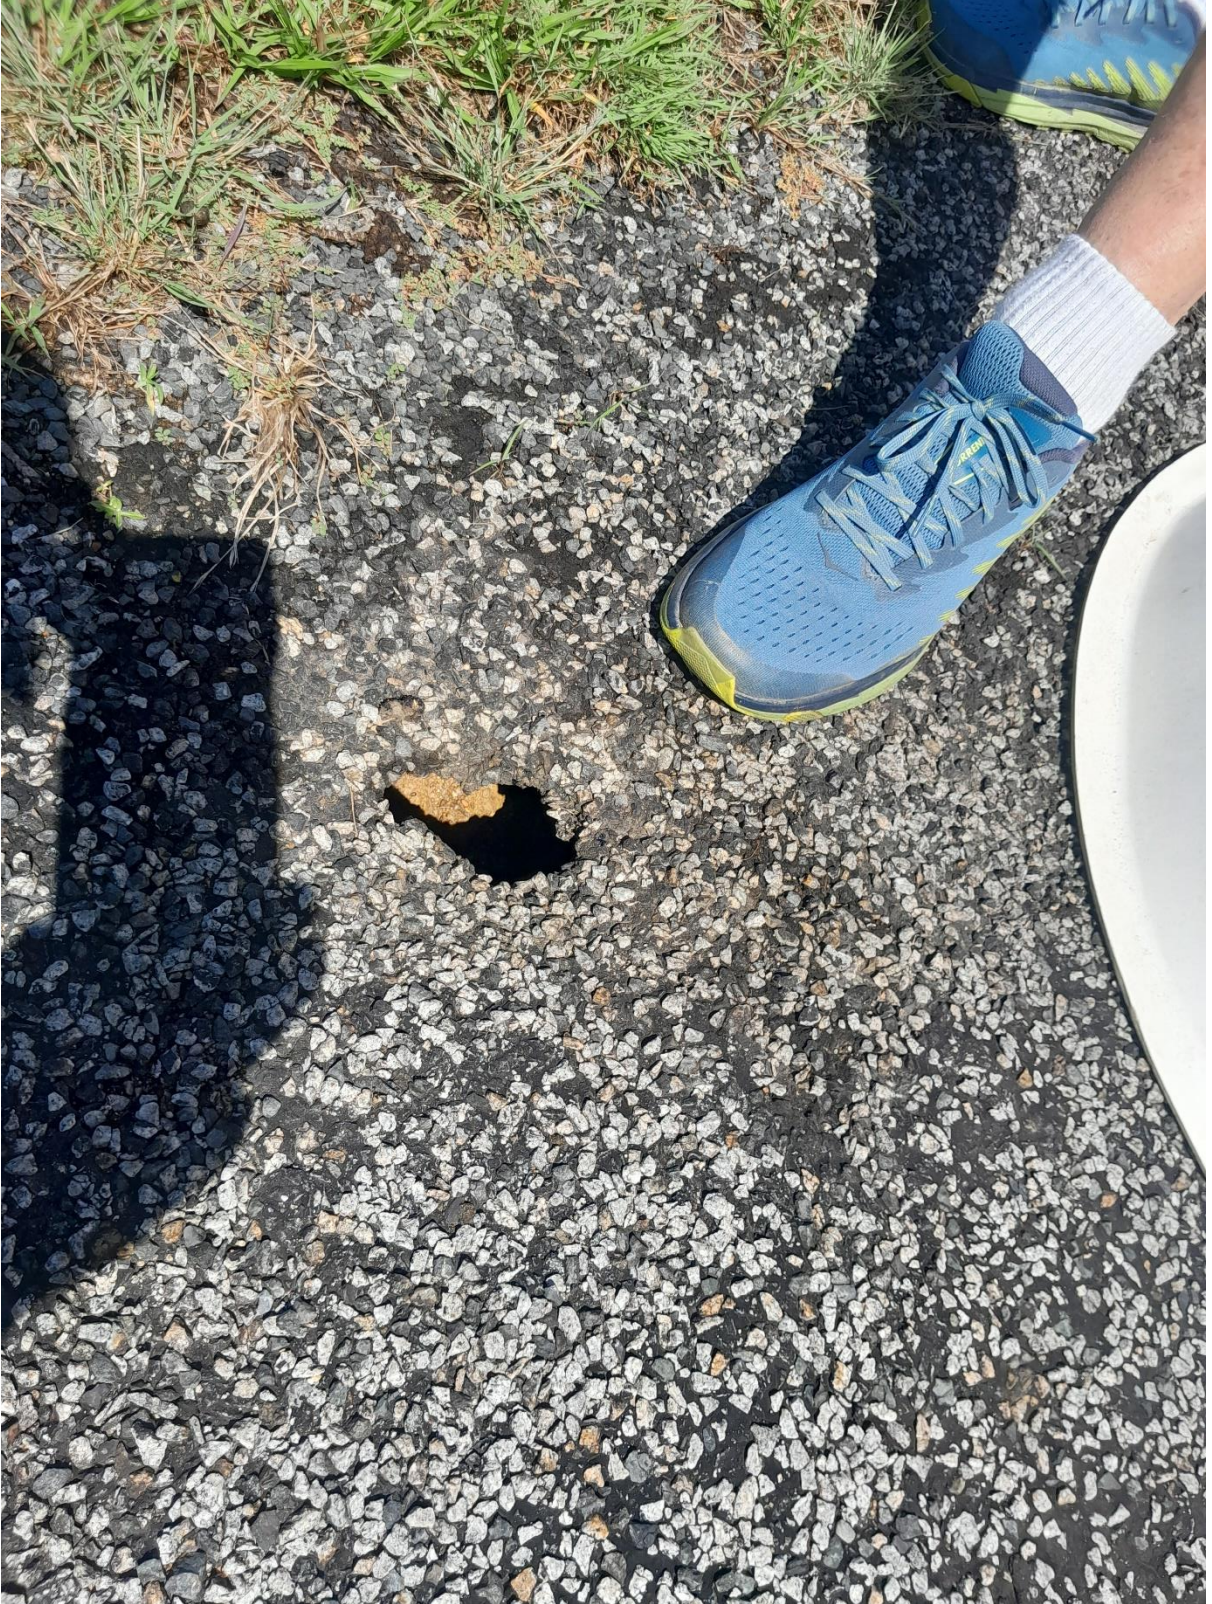
See pictures below showing detail of the damage.
